## Blue Lake Campground – All American RV Resorts I, LLC Sequence of Site Impacts

5453 Blue Lake Road, Churubusco, Whitley County, Indiana

### Aerial Photography Reviewed:

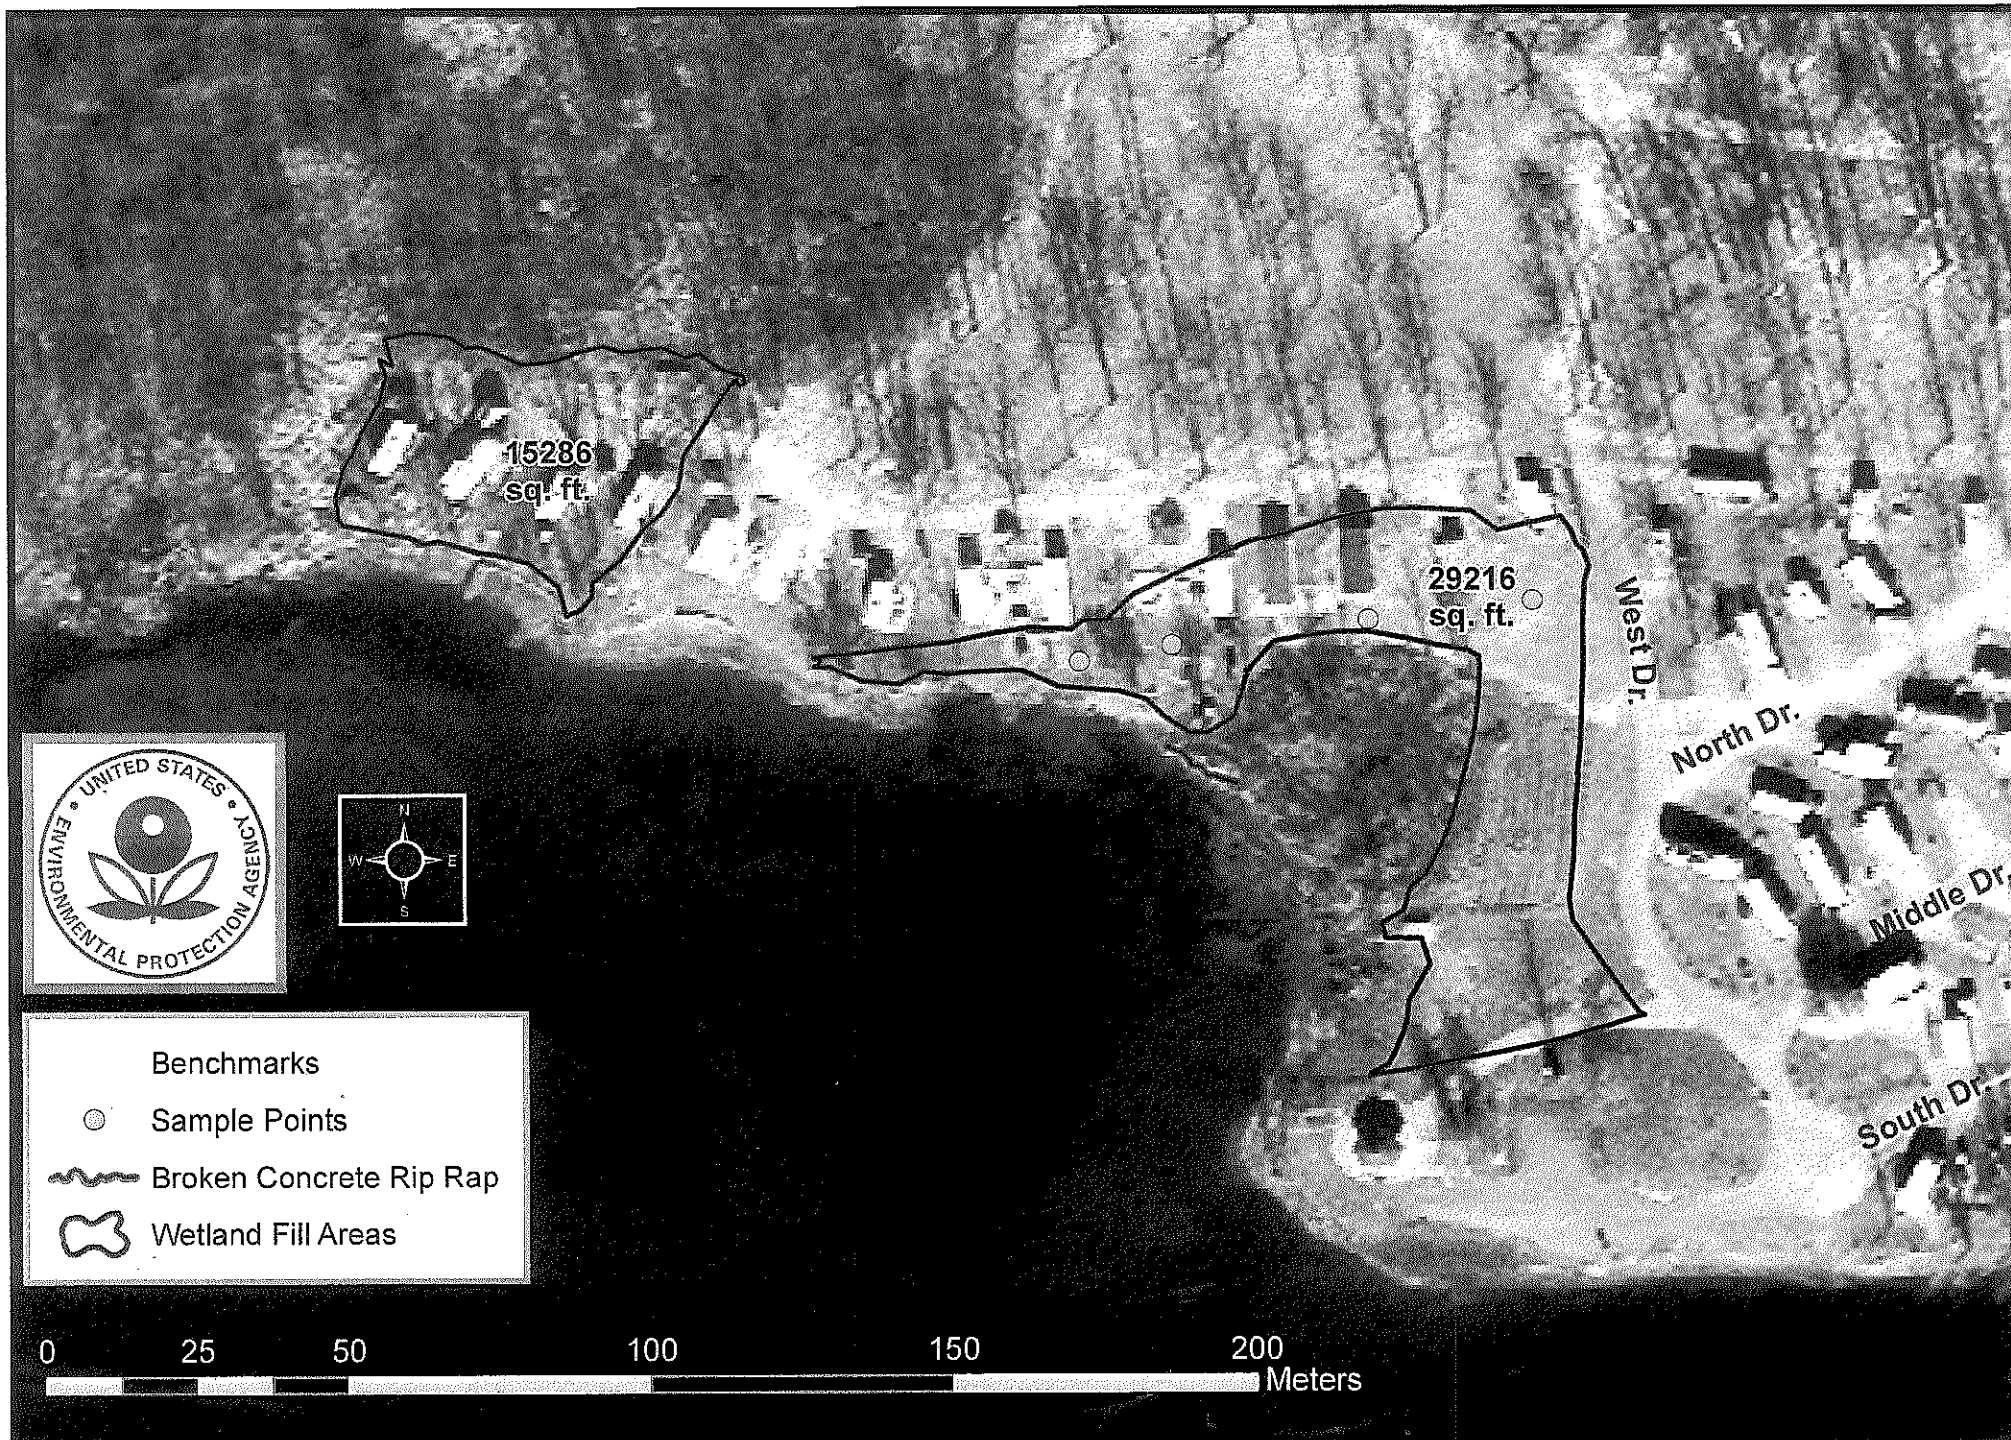
# All American RV Resorts I's Blue Lake Campground

# All-American Fill

02-03 0.14 (6,165 sq ft)

03-05 0.04

3/05-7/05 0.06 + 0.01 (511 sq ft)  
(2,665 sq ft)

7/05-7/06 0.02 (810 sq ft)

06-07 0.03 (1,129 sq ft)

07-08 0.09 + 0.24 = 0.33  
10,435 W of W Dr.  $\pi$

08-10 0.16 + 0.09

10-11 0.26 0.09 (refilled)  
in bridge

11-12 - 0.11 (refill)  
west of West Dr.

Total Fill Areas: 1.03 acres and 0.18 acres refilled

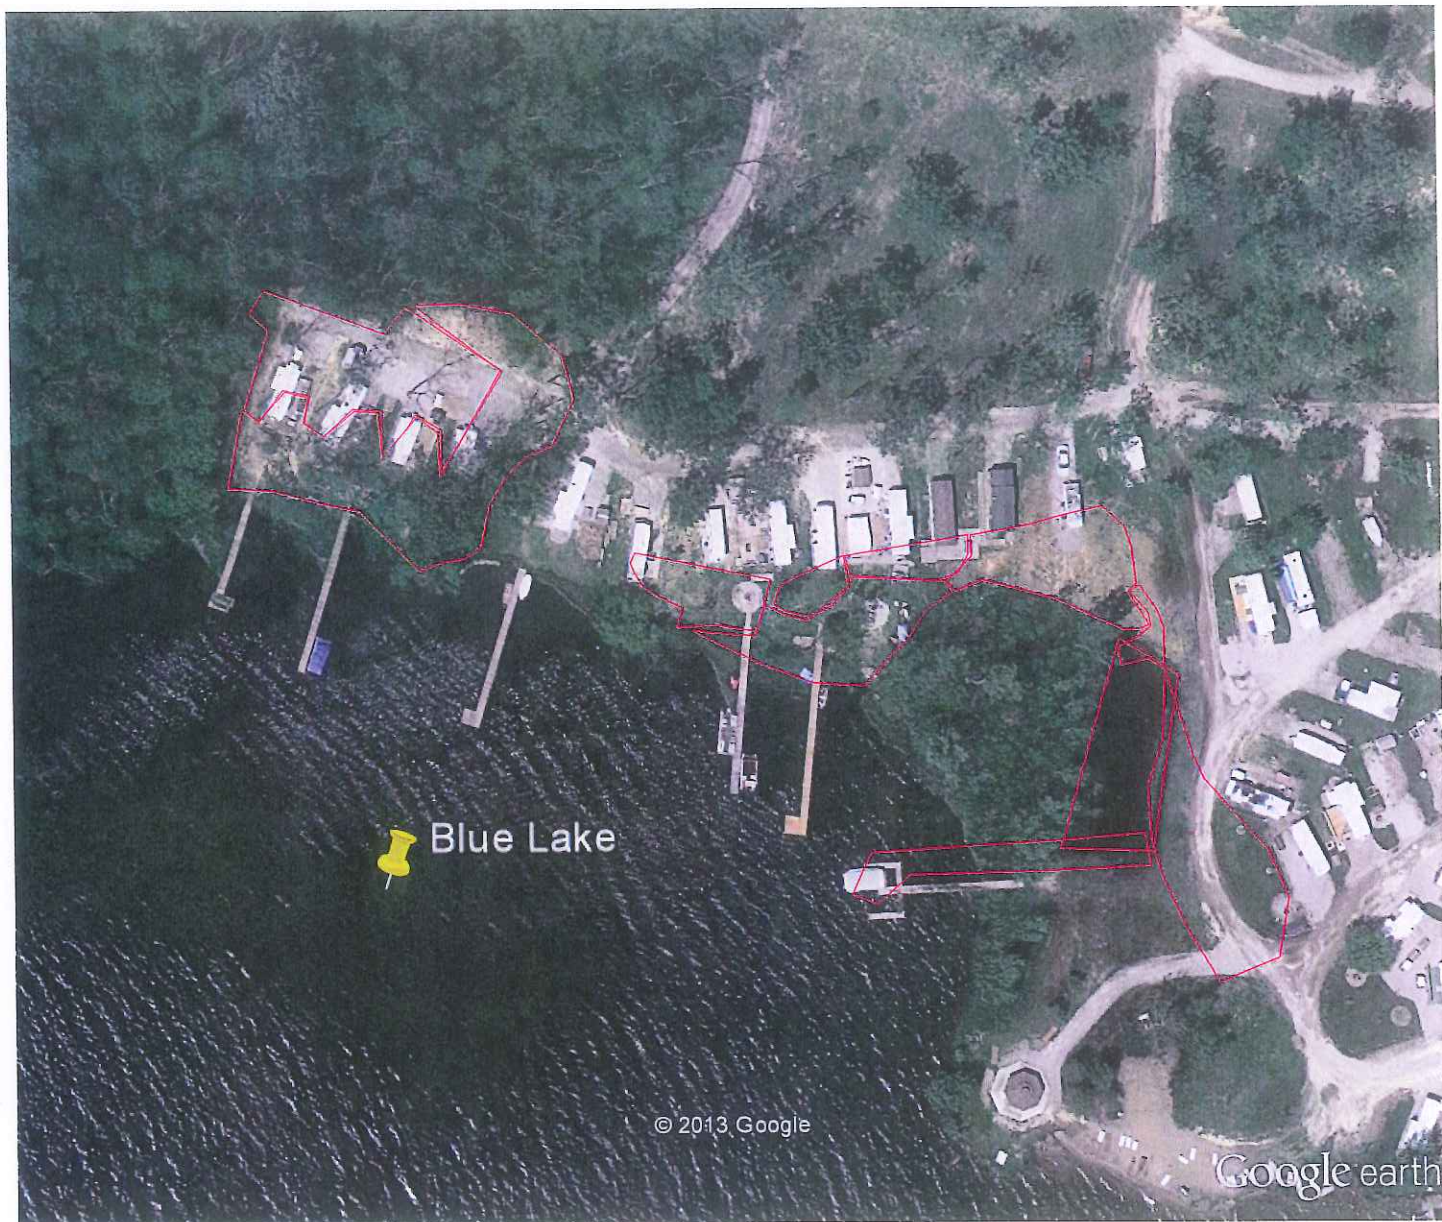
$$0.09 + 0.26 = 0.35A$$

refill

10. June 1, 2011 (Google Earth color image) – This is a growing season image in which the canopy can obscure ground level features. The northmost fill along the shoreline has expanded by 0.26 acres and three trailers and two piers are in place. Another trailer space is available. Along the north flank of the wetland area, the photo quality allows the fill/disturbed area behind the trailers and the lakeshore to be delineated. Approximately 0.09 acres has been filled for lake access, lawn and fire pits. Additional fill has been placed at the wetland 'bulge'. Approximately 0.09 acres has been largely refilled since being filled in between 2007 and 2008. The area west of 'West Dr.', appearing wetter in 2010 than in 2008 (when first filled) now has standing water throughout.

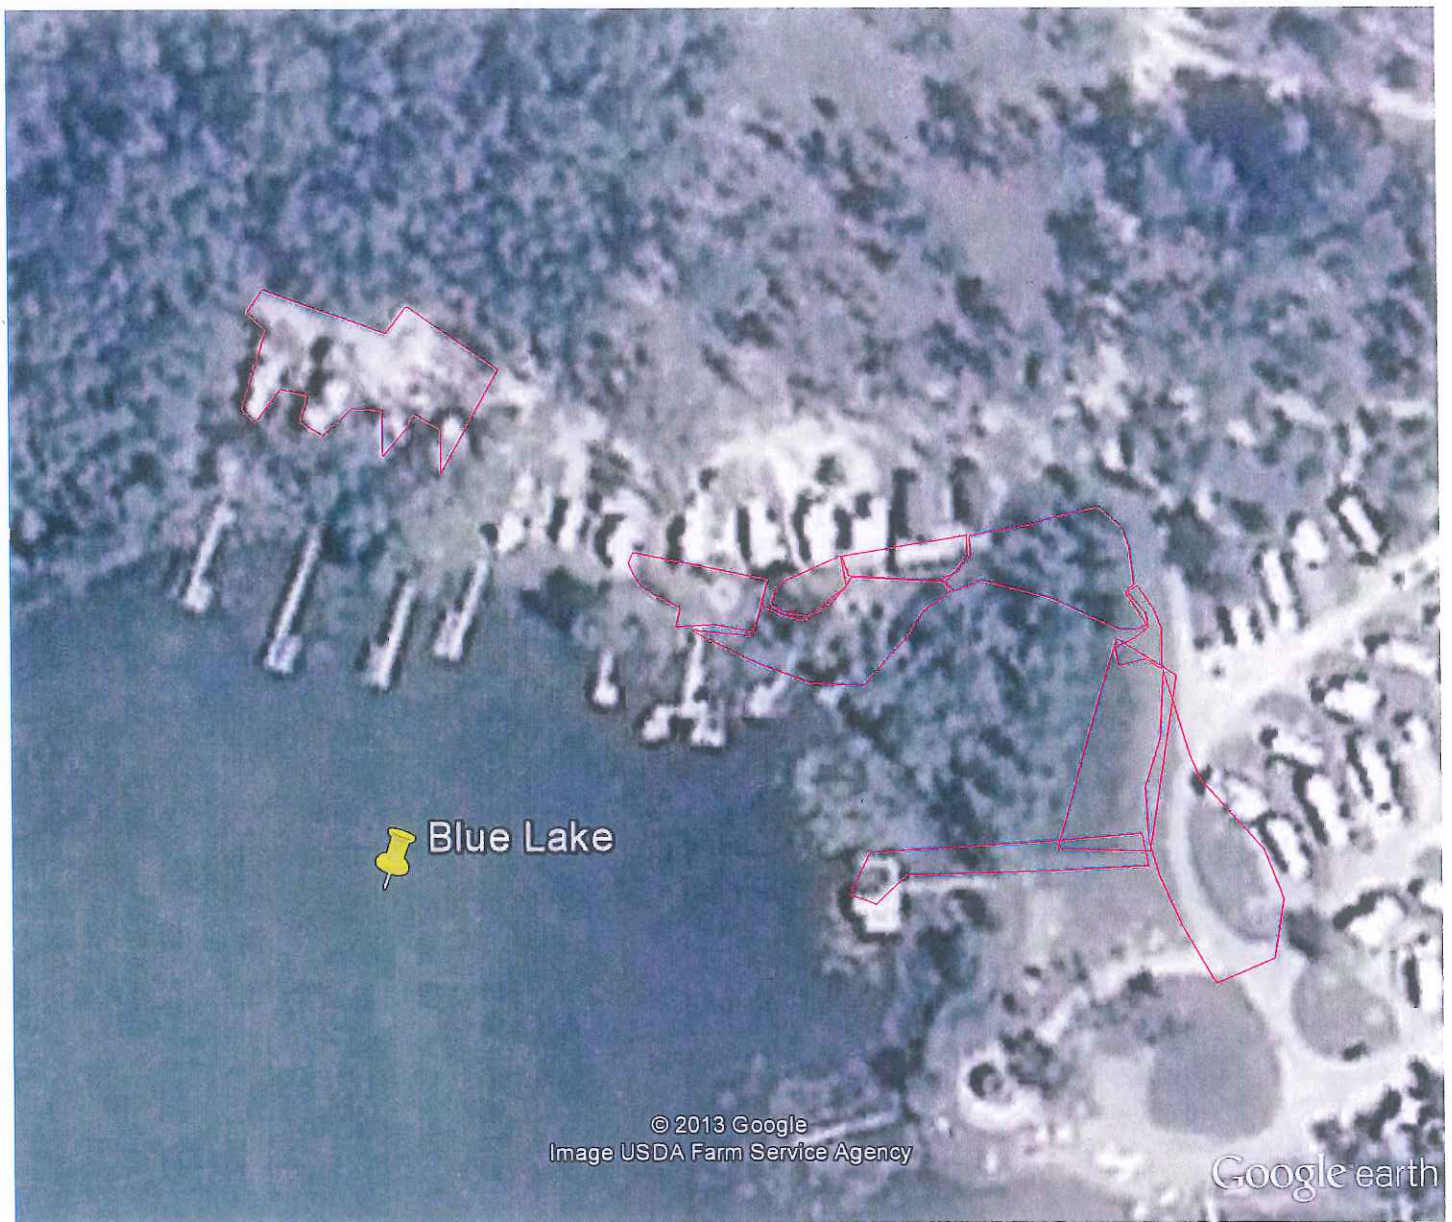
$$0.16 + 0.09 = 0.25A$$

9. June 20, 2010 (USDA-FSA/Google Earth color image) – This is a growing season image of medium quality. The major change in this image is the addition of disturbance/filling along the shoreline north of the 'North-South' access road's cul-de-sac (north of all previous disturbances). This area has room for four trailers, but only two appear to be in place. The disturbance/filling does not extend all the way to the shoreline, but is concentrated about 100 feet from the shoreline in a landward direction where an access road is located and further fill/disturbance is immediately adjacent on the waterward side. Approximately 0.16 acres of forested wetland fill/disturbance has occurred, though, the fill has not reached the lakeshore. However, three piers are located at the shoreline and project into the lake. Otherwise, the filling/disturbance west of 'West Dr.' appears wetter than filled areas to the south and east, i.e., the ground is darker.

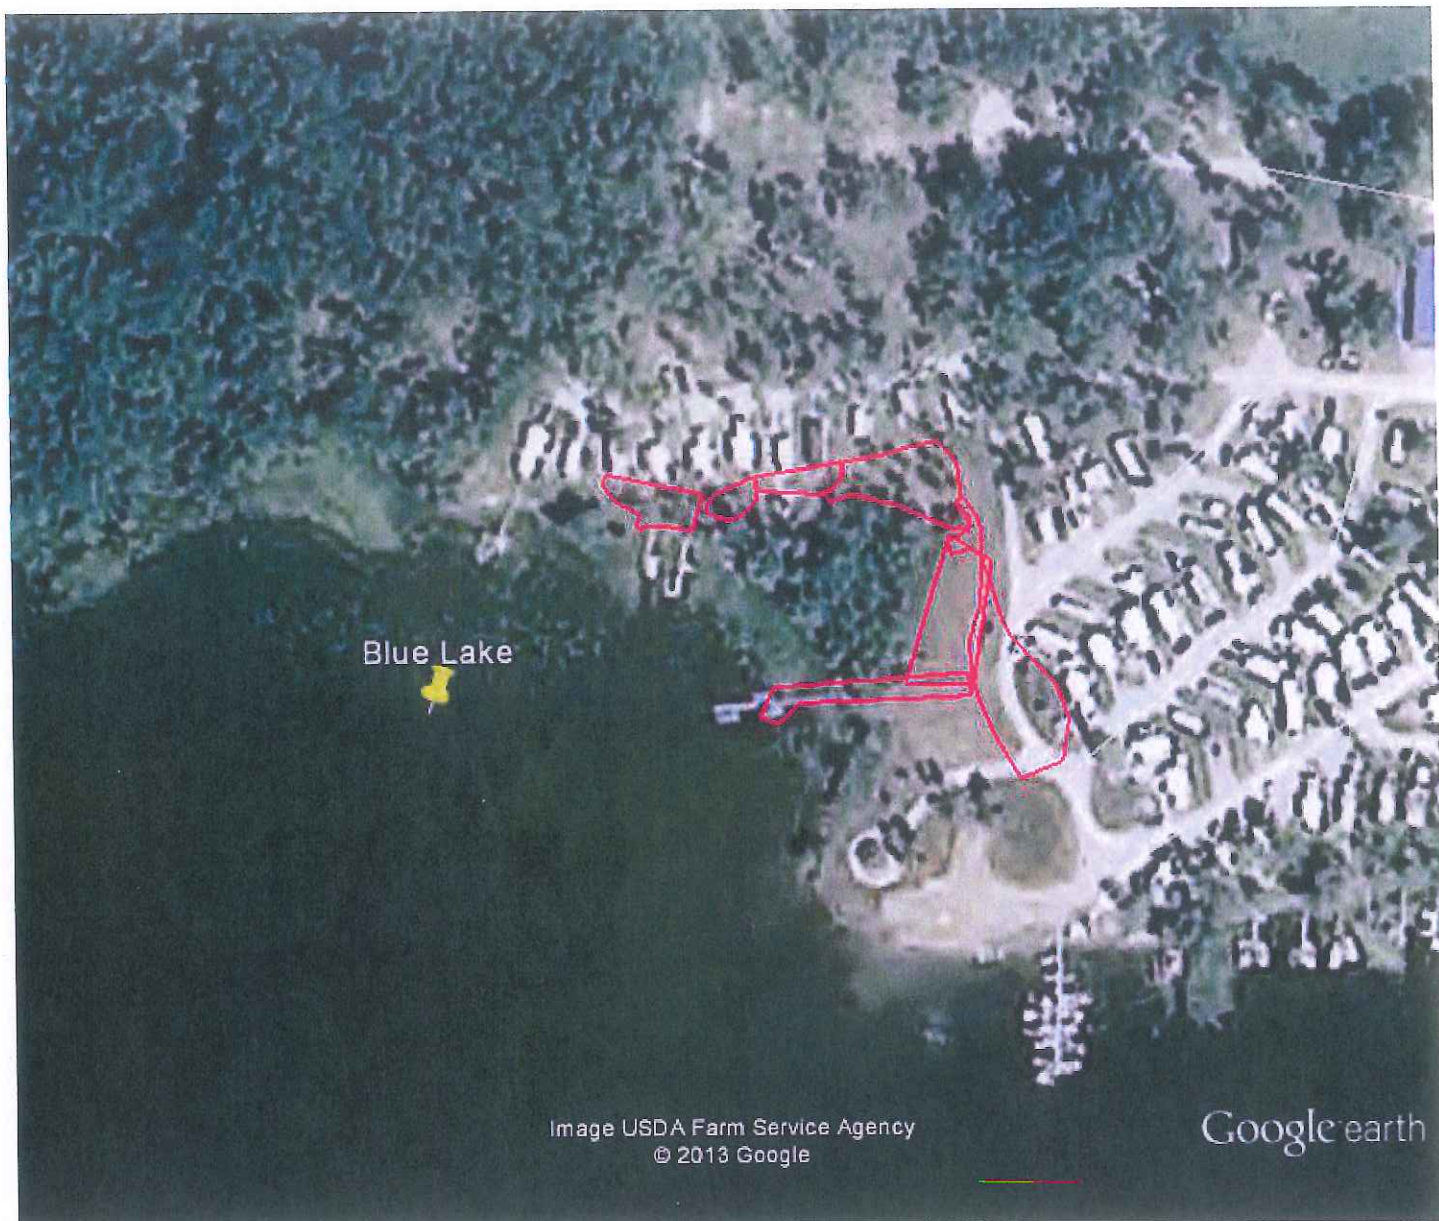
$$0.09 + 0.11 = 0.20A$$

6/18/08

8. June 19, 2008 (USDA-FSA/Google Earth color image) – Photo quality is again poor and taken during the growing where the canopy can obscure ground features. A new road way has been constructed from the 'West Dr.' west to the old location of the 'North-South' road's cul-de-sac. A line of trailers is in place to the south of this new road. Adding trailers in this location has resulted in additional wetland disturbance/filling along the back end of these new trailers – further to the northeast of similar filling in this area from the 2006-07 images. Approximately 0.07 acres of the wetland 'bulge' has been filled in as well as areas contiguous to it to the southwest and southeast. Further filling/disturbance has taken place west of the 'West Dr.' from the wetland 'bulge' tip south of the 'South Dr.'s' peninsula. At the peninsula, a gazebo and access road have been built further impacting the wetland areas with fill material. Approximately 0.22 acres of additional fill has been placed to allow the gazebo access road construction as well as those areas of fill west of 'West Dr.'

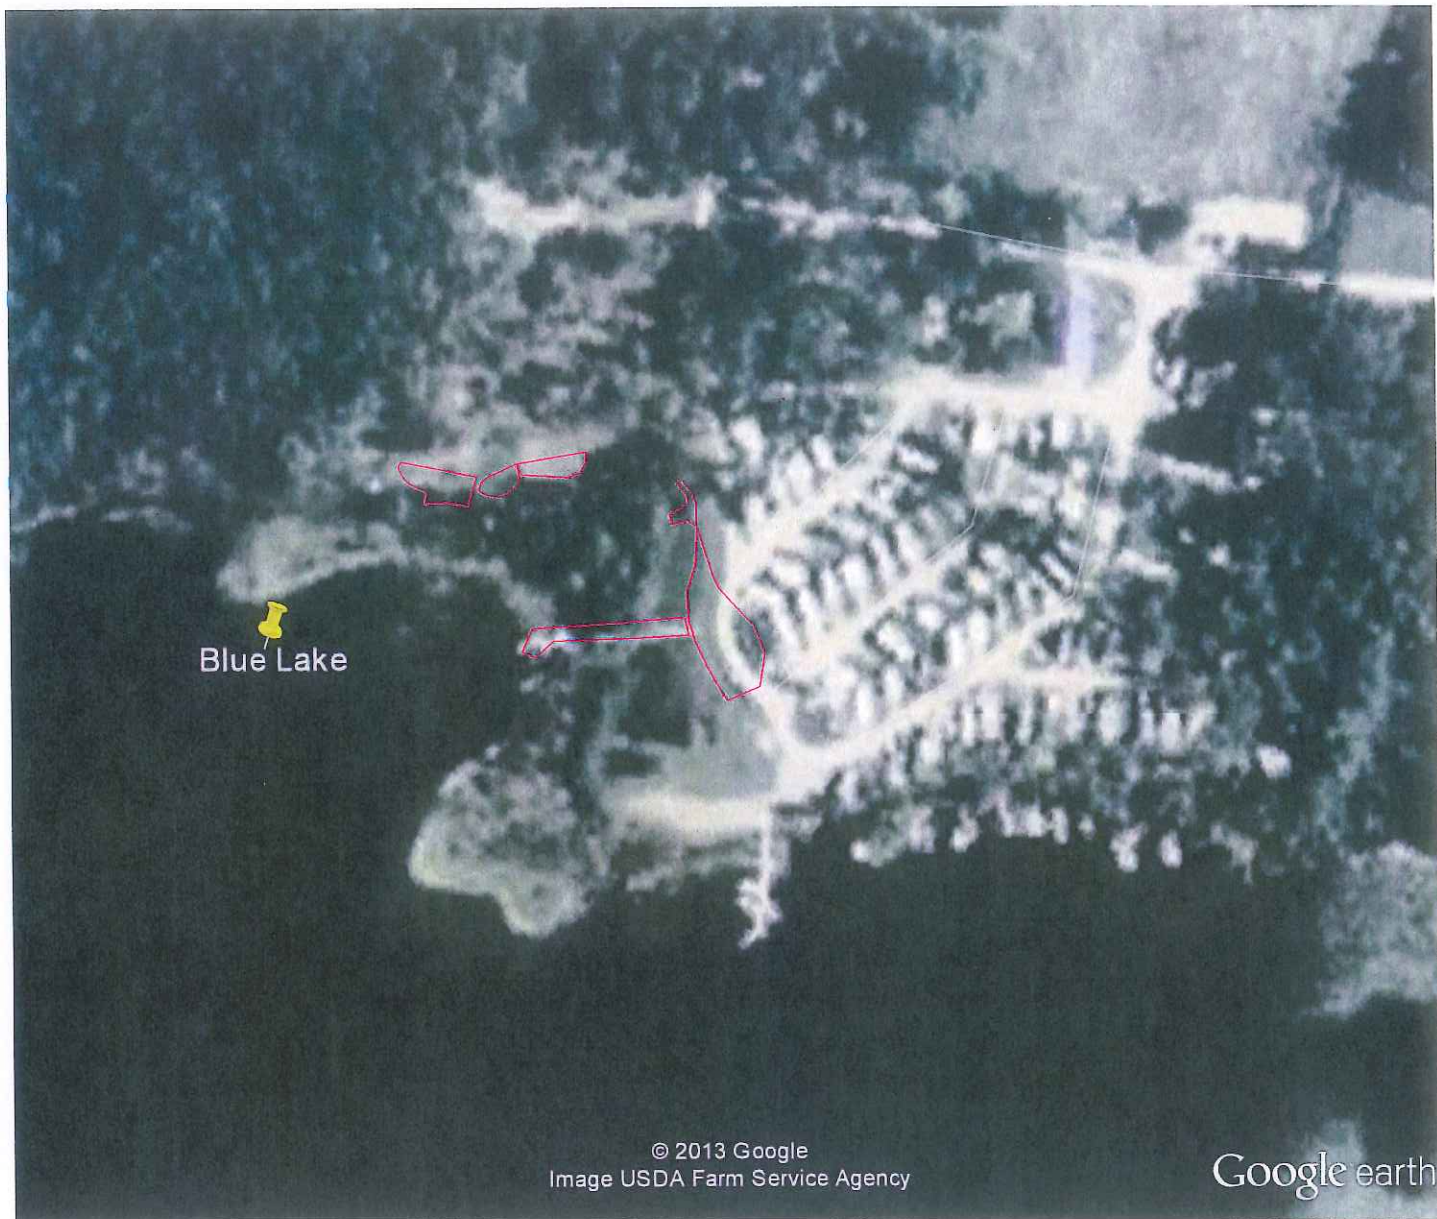
0.03 A

7-1-07

7. July 2, 2007 (USDA-FSA/Google Earth color image) – Another poor quality photograph with little definition. However, there is a small amount of additional disturbance along the wetland's

north flank – a little further northeast than the previous year. Approximately, 1,129 square feet (0.03 acres) have been disturbed/filled.

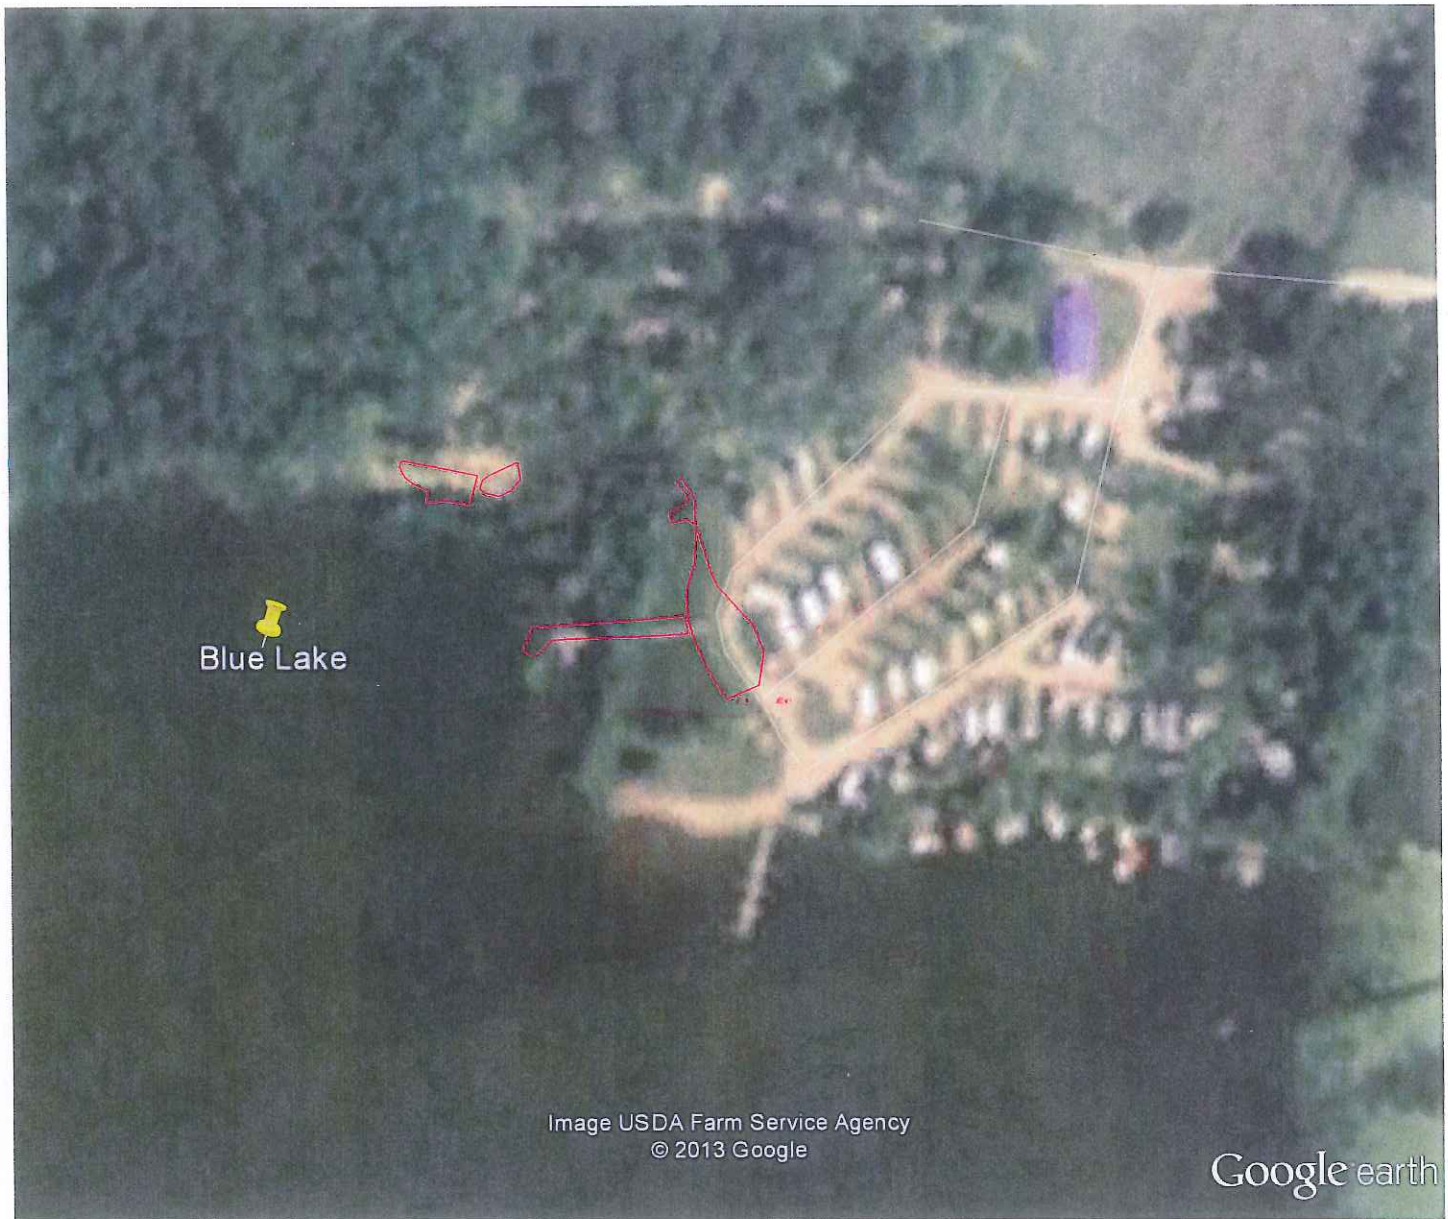
0.02A

7-26-06

6. July 27, 2006 (USDA-FSA/Google Earth color image) – The photo quality is again poor with little definition of features. However, there is additional disturbance to the northeast of the former location of the large trailer/building. The disturbance encompasses approximately 810 square feet (0.02 acres).<sup>2</sup> The location of the 336 foot line of disturbance reflects a distinctly different vegetation signature compared to wetland areas to the west and east of it.

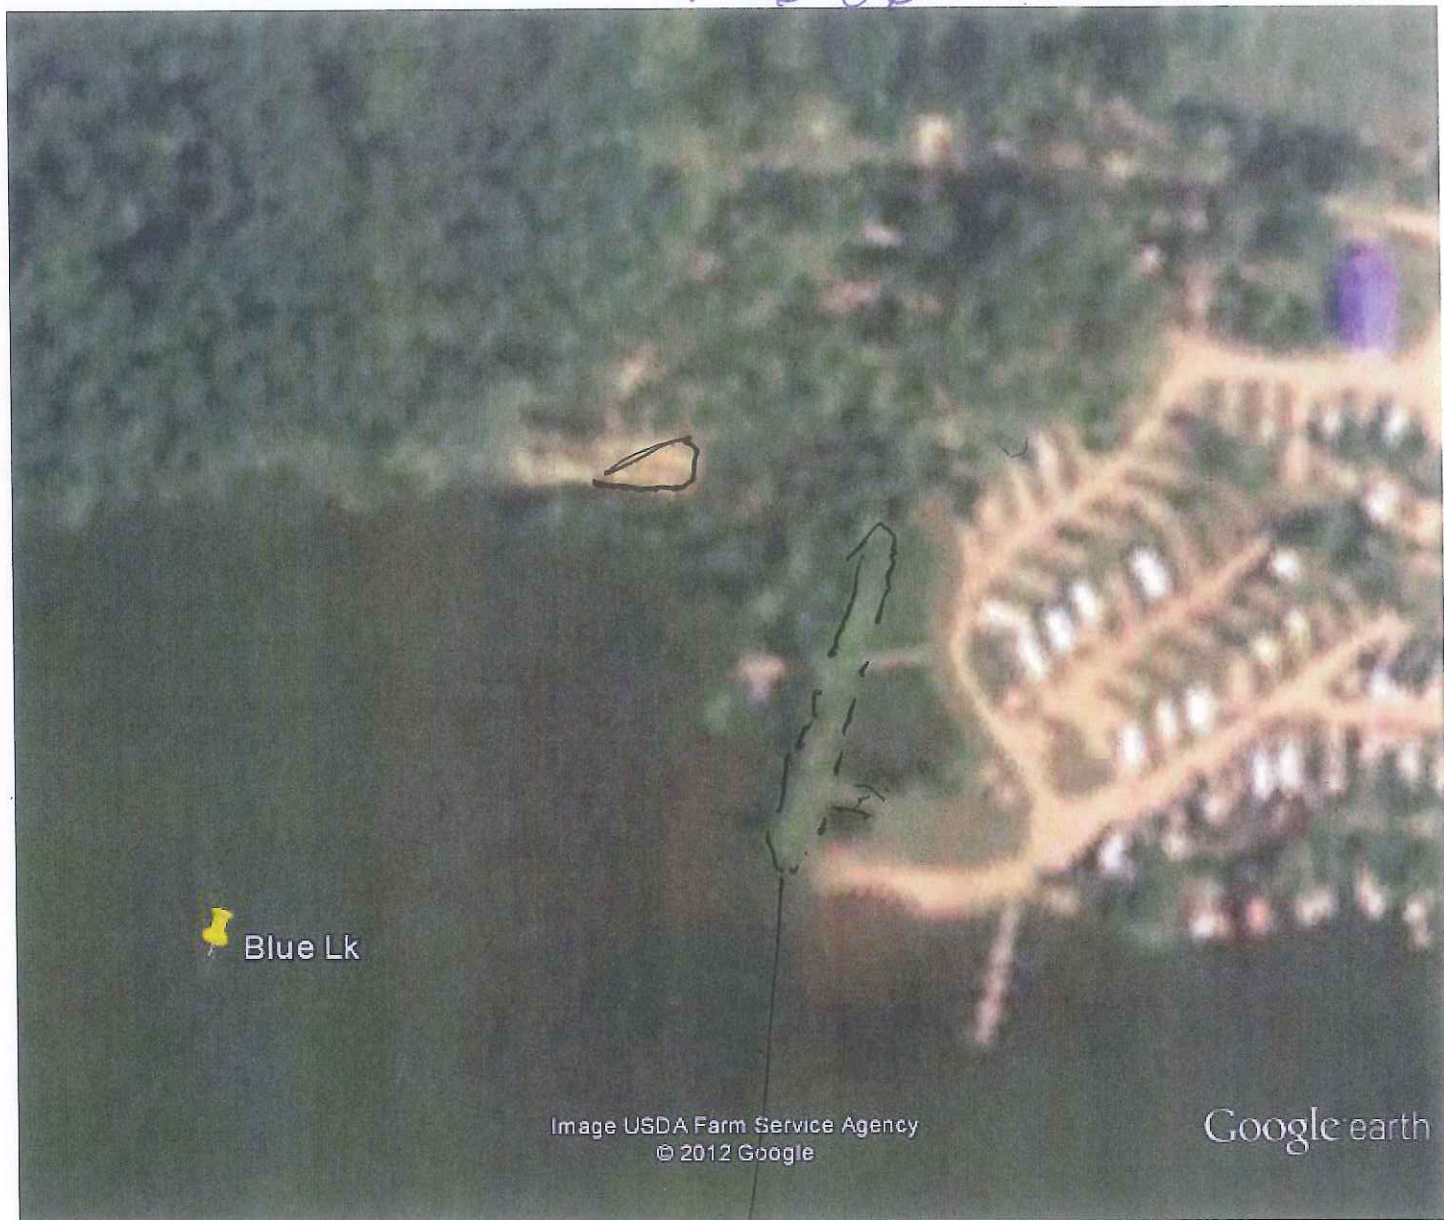
Shows on '98 photo as  
bright color - probably  
fill

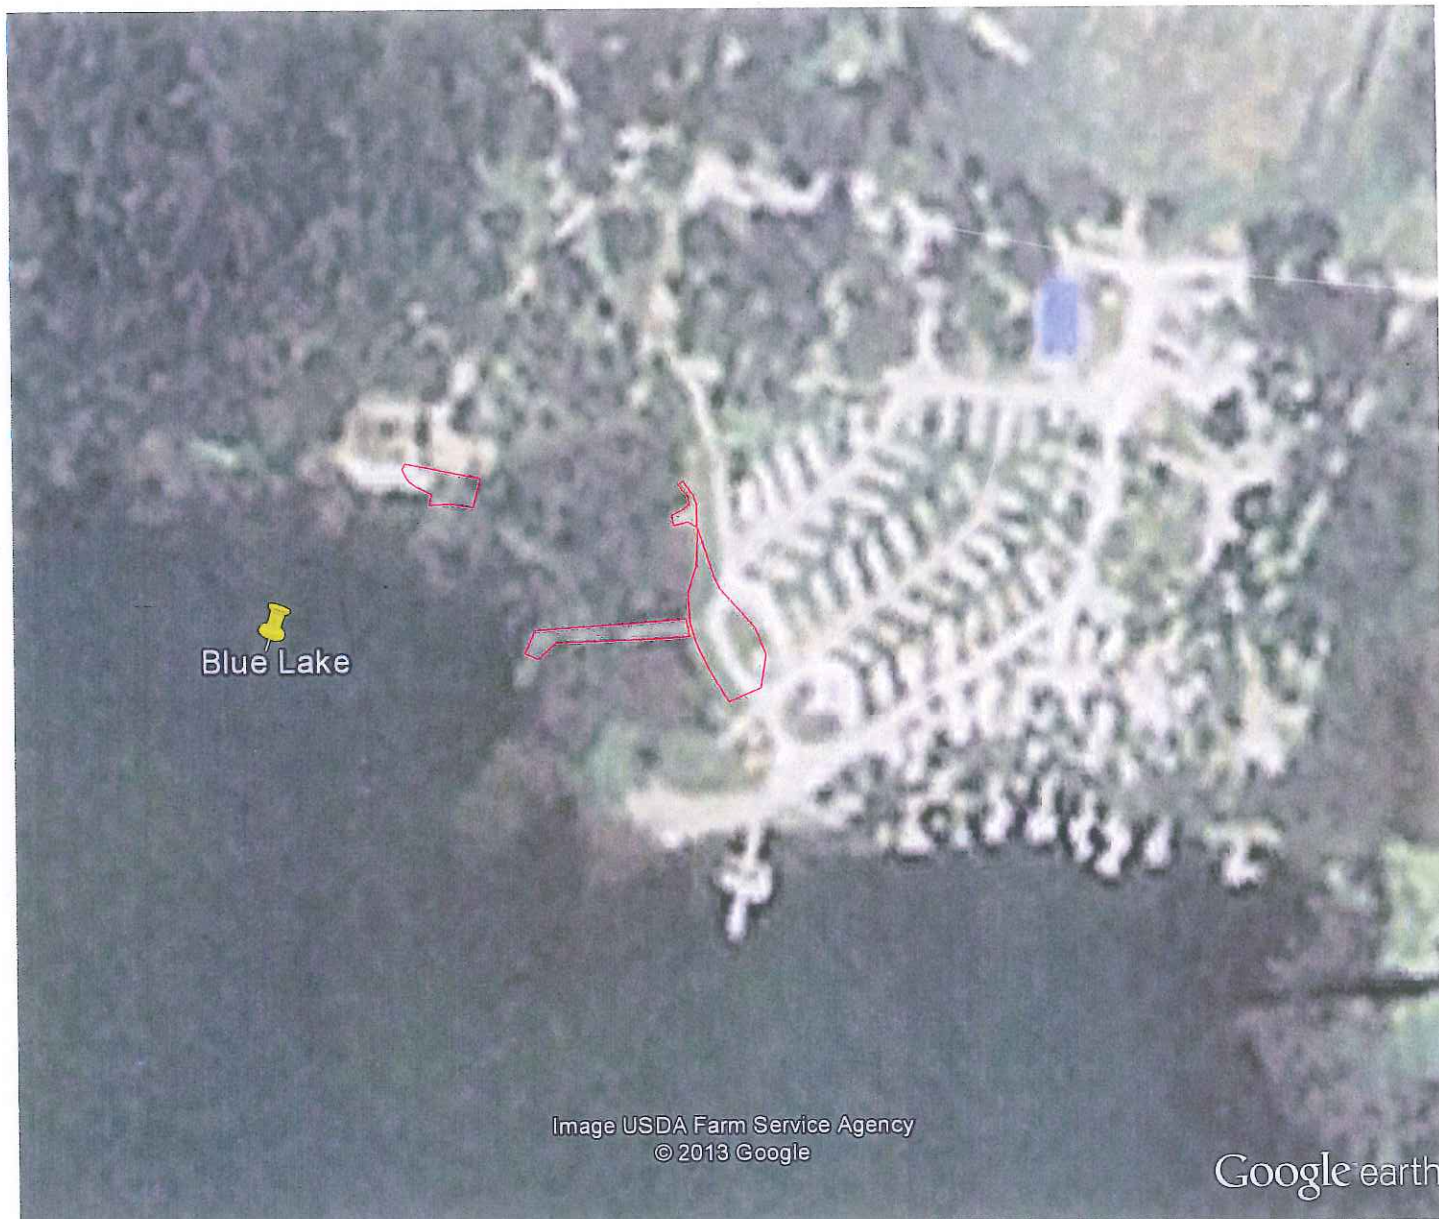
$$0.06 + 0.01 = 0.07 A$$

6-30-05

5. July 1, 2005 (USDA-FSA/Google Earth color image) – Photo quality is very poor and the photo is during the growing season where canopy coverage can obscure ground conditions. However, additional wetland fill stands out in the form of a linear access to the lakeshore from the westernmost outer curve of 'West' Dr. The fill area in wetlands is 2,666 square feet (0.06 acres). In addition, there is additional disturbance along the west edge of 'West' Dr. north of the previous fill in this area. The wetland fill totals 511 square feet (0.01 acres). Additional land disturbance is occurring at the 'North-South' access road. The road may be abandoned because the cul-de-sac area has been disturbed and the large trailer/building has been removed. Further land disturbances are very near or at the wetland's north flank immediately northeast of the former large trailer/building and at the wetland 'bulge' tip. The south edge of the 'South' Dr. peninsula also had additional land disturbance down to the shoreline and further west than seen in the July 2003 photo.

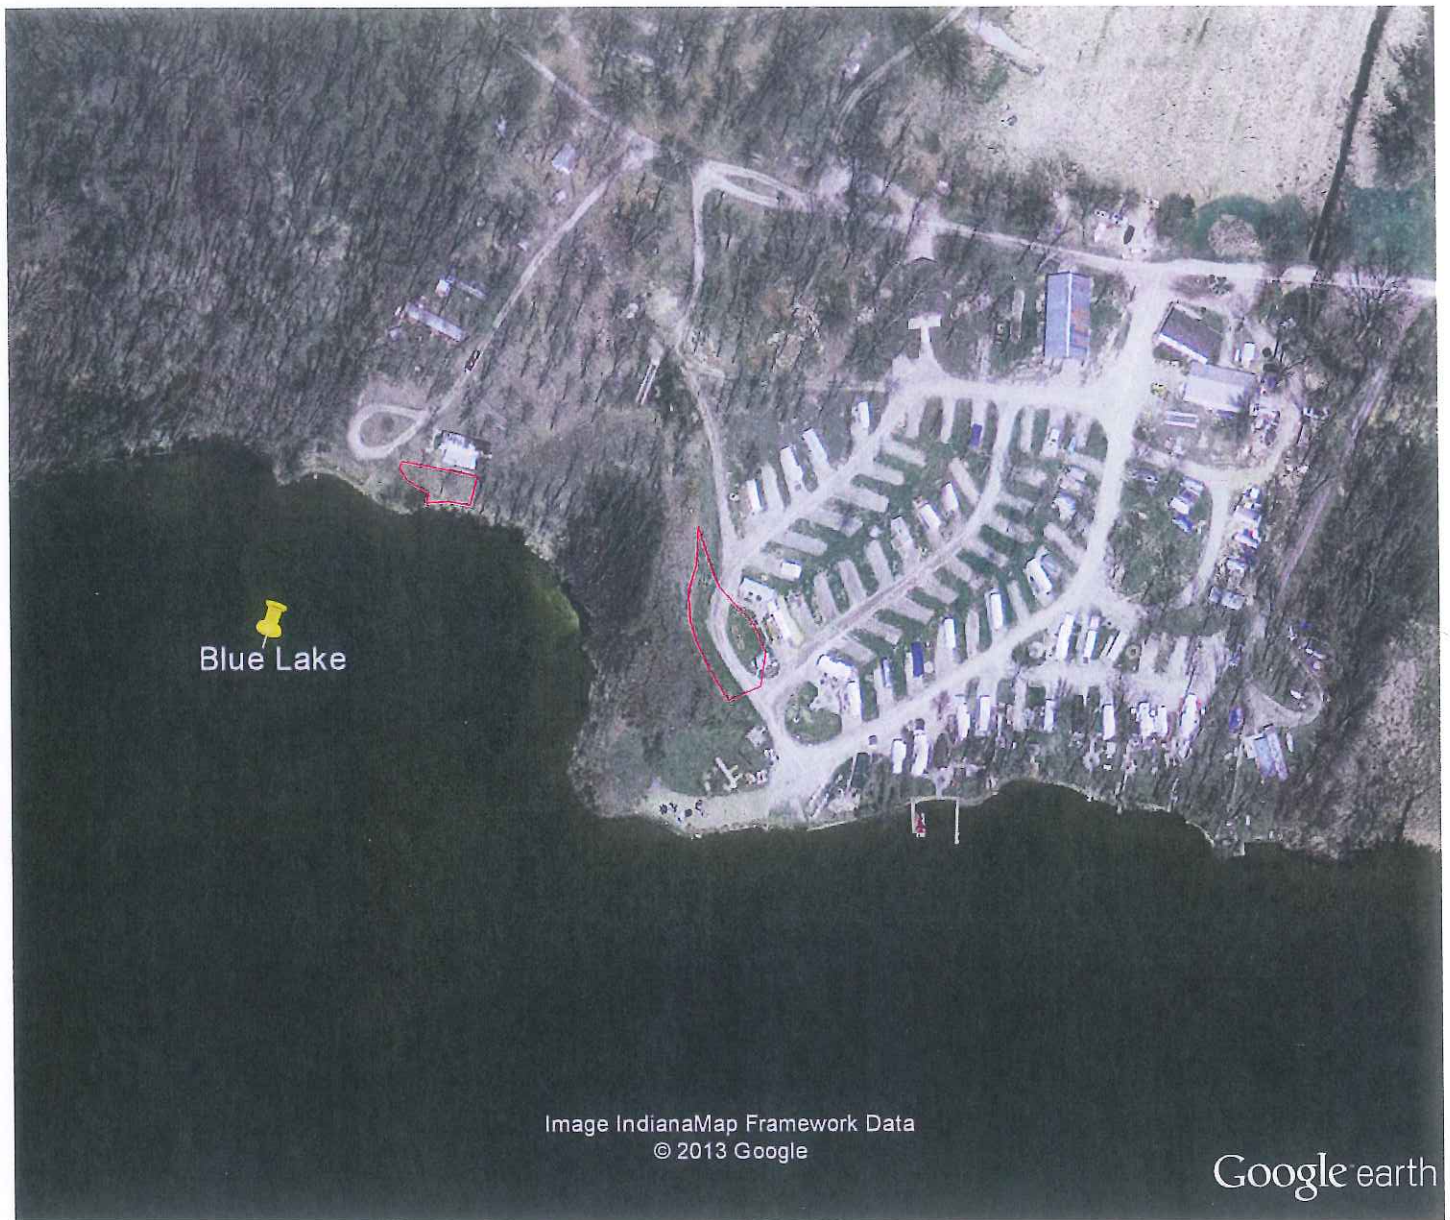
MR. 2005

0.04 A

4. March 1, 2005 (IndianaMap Framework Data/Google Earth color image) – This is a leaf off photo with excellent resolution. Additional fill covering 0.04 acres has been placed south of the large trailer/building to the lakeshore. The 'path' from the aforementioned western trailer (between the wetland 'bulge' tip and the southernmost 'East-West' access road) is no longer visible, but previous disturbance close to the lakeshore is more visible and can be parsed from the surrounding wetland area. Otherwise, the northeast tip of the wetland 'bulge' and the wetland's north flank, excepting the fill noted above, are unchanged. The wetland edge is clearly definable by a change in vegetation and photo texture/color as contrasted with adjacent upland.

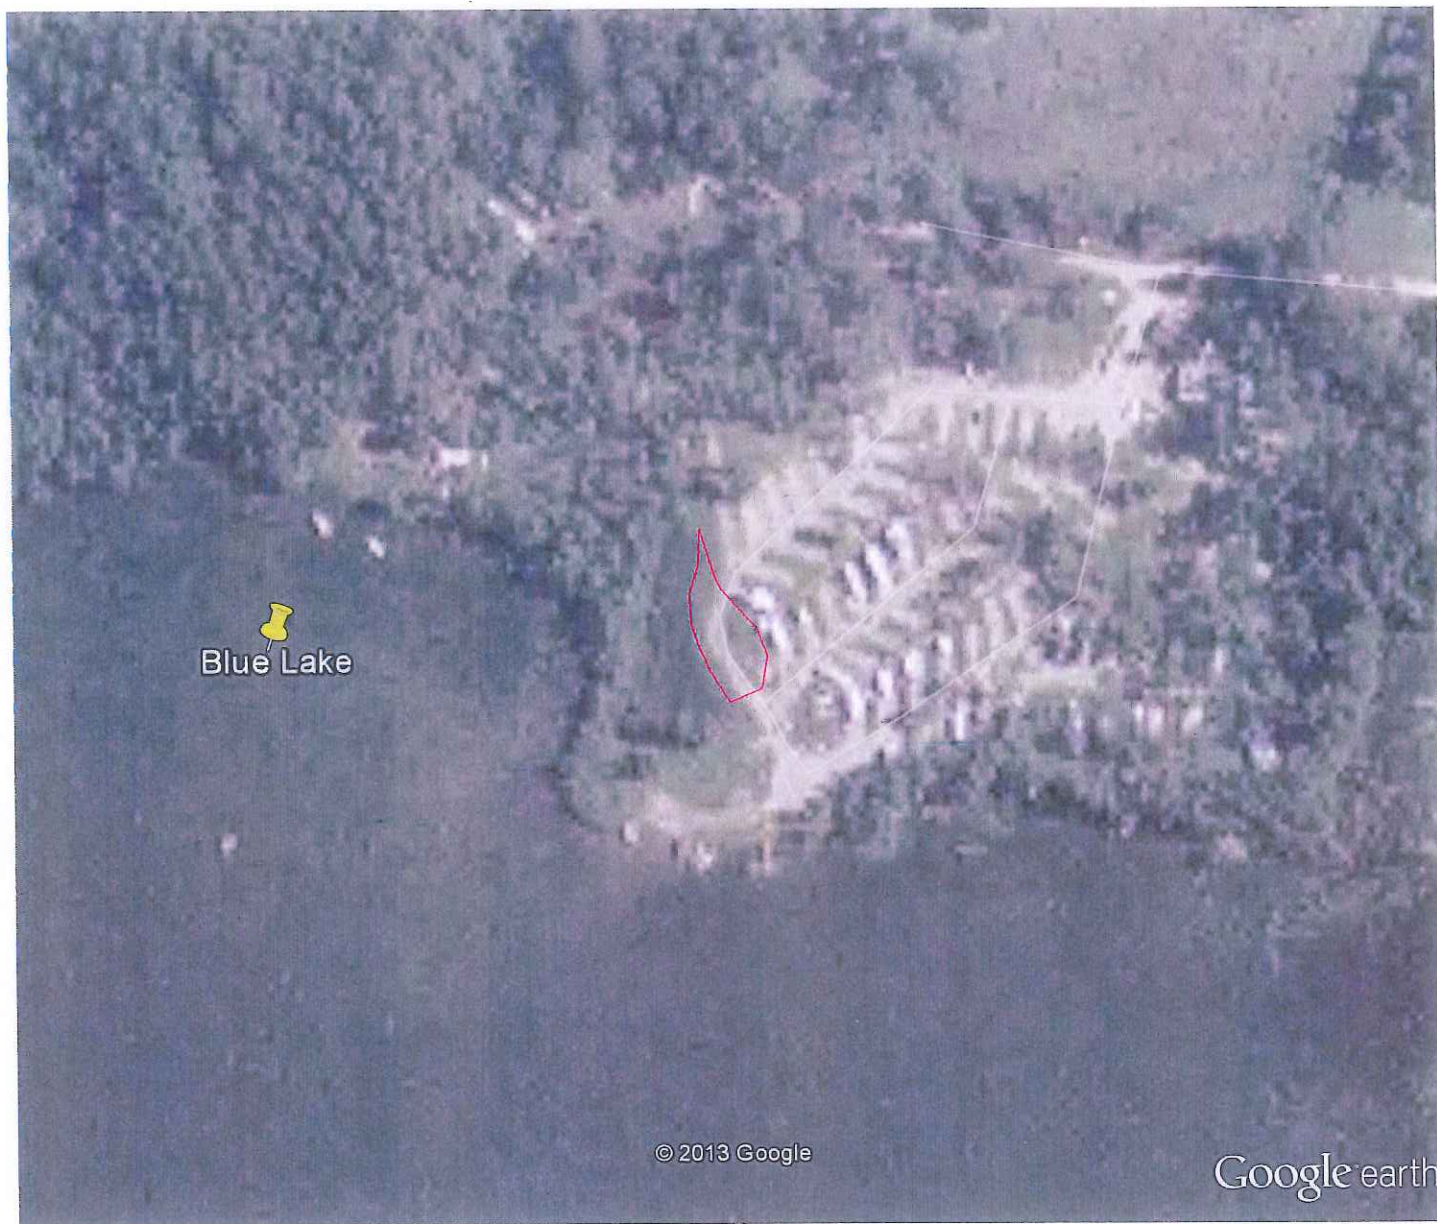
0.14 A

7-12-03

3. July 12, 2003 (USDA-FSA/Google Earth color image) – This image is the digitized version of oblique photographs taken for Farm Bill compliance purposes and are taken in the growing season where tree canopies block much of the ground surface. Further, the photographic quality is limited and becomes pixilated when zooming in (a Google Earth feature). Major changes have occurred within the campground. The contemporary version of the road network is established in that the South, Middle, West and North Drives are in place. 'West' drive construction has intruded into the wetland approximately 6,165 square feet (0.14 acres). The south edge of the 'South' drive peninsula has a disturbance band along the shoreline west of the cul-de-sac. Further, two trees or shrubs have grown up on near the north edge of the 'South' drive peninsula – very near its border with wetlands. These two trees/shrubs were probably transplanted as they were not in evidence in the 2002 photo.
